Monthly Oversight Report 45
ACS NPL Site
Griffith, Indiana
August 28, 2004 - September 24, 2004

USEPA/RAC VII
American Chemical Services RAO (057-ROBF-05J7)

Subject: Monthly Oversight Summary Report
No. 45 for September 2004

Monthly Oversight Summary Report No. 45
ACS Superfund Site WA57, 46526.238

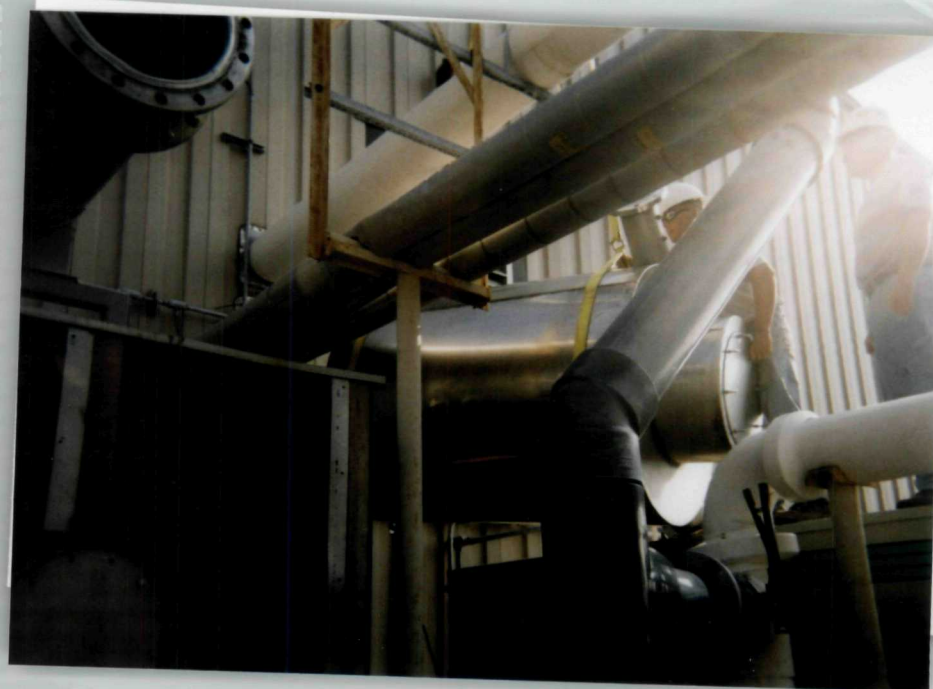
Description: Photo facing north showing new knockout tank being lowered into position between thermox 1 (L) and catalytic oxidizer (R)

On September 13, Ryan and Central Crane lifted the new stainless steel knockout tank and placed it on the concrete pad between the catalytic oxidizer and thermox 1. Ryan continued installation of the vapor piping to integrate the new knockout tank into the ISVE systems.

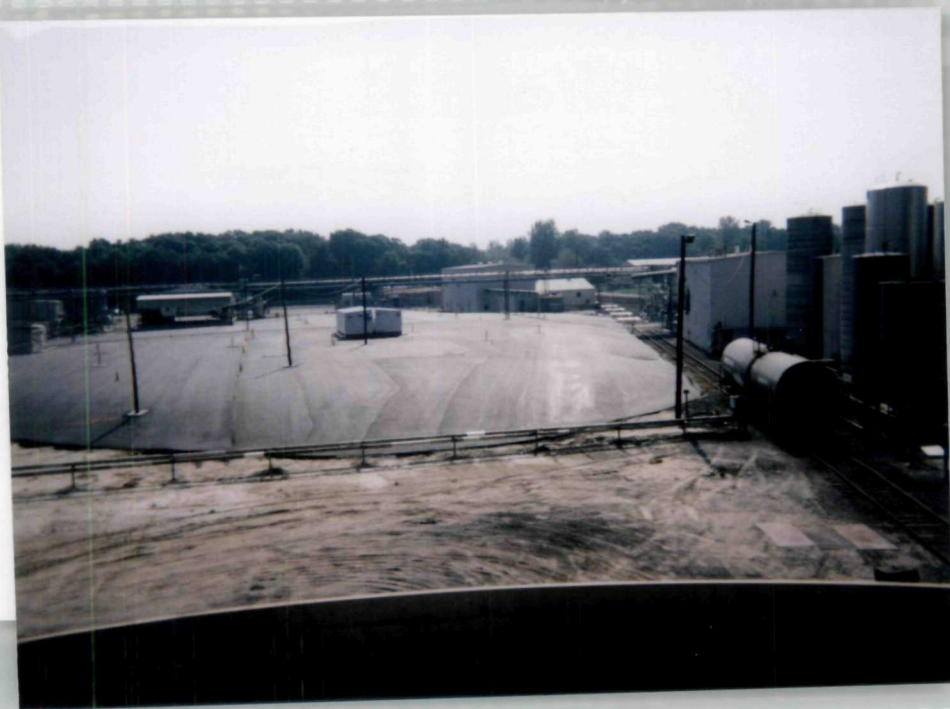
Description: Photo facing east showing north side of SBPA asphalt concrete cover paving.

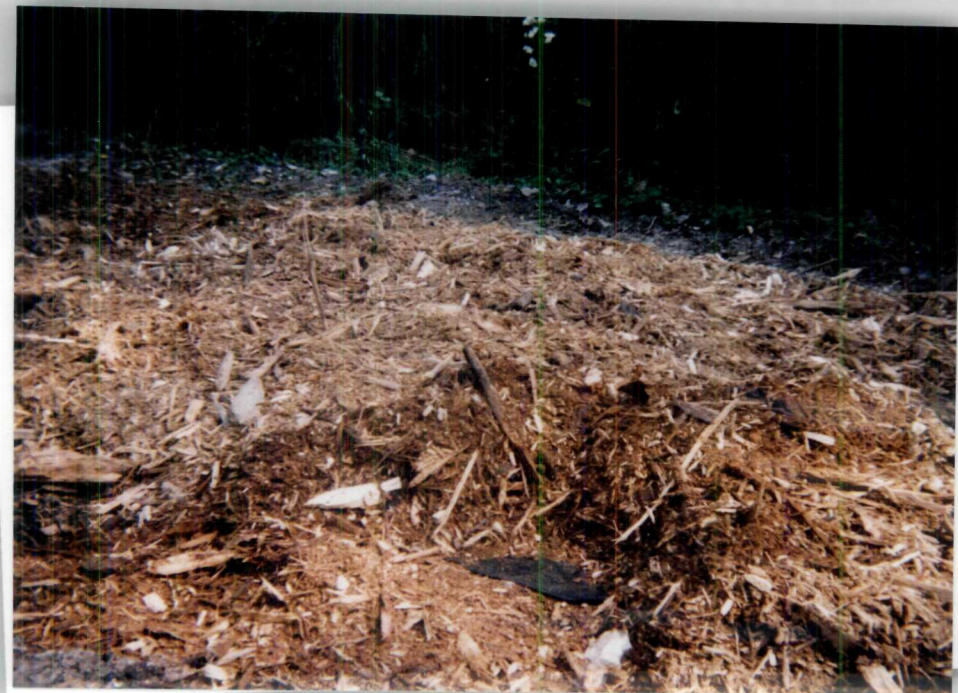
Description: Photo facing northwest showing access paths to
MW10 where large pile of wood chips had been.
See Roll 61, Photo 18 in Monthly Report 44 and
Roll 58, Photo 22 in Monthly Report 41 for
comparison.

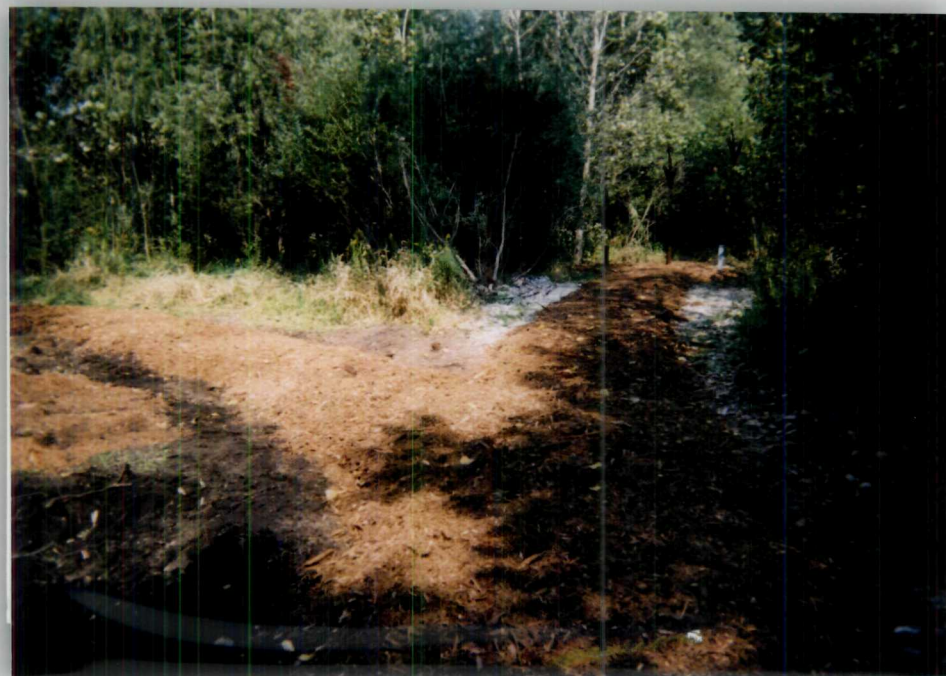
Site: American Chemical Service, Inc.
 Proj. #: 46526
 Roll: 66 Photo #4
 Date: 09-13-04 Time: 1120
 Photographer: Larry Campbell
 Description: Photo facing north showing edge of wood chips on pathway. Note underlying black filter fabric.

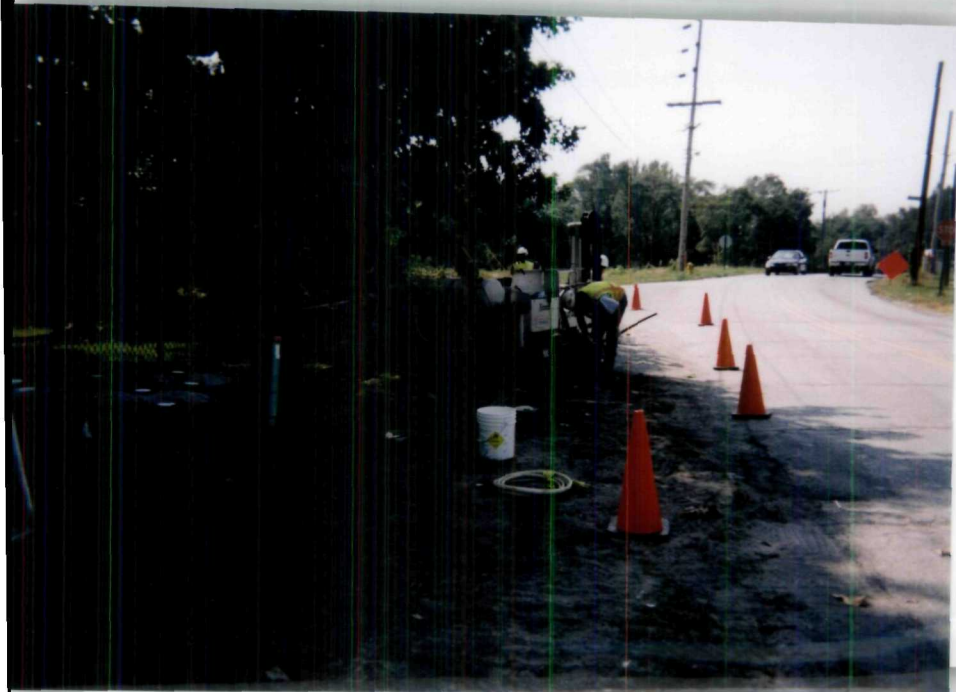
Site: American Chemical Service, Inc.
 Proj. #: 46526
 Roll: 66 Photo #7
 Date: 09-13-04 Time: 1145
 Photographer: Larry Campbell
 Description: Photo facing south showing ISOTEC tanks
 and pumps injecting west edge of yard and
 along Colfax Avenue.

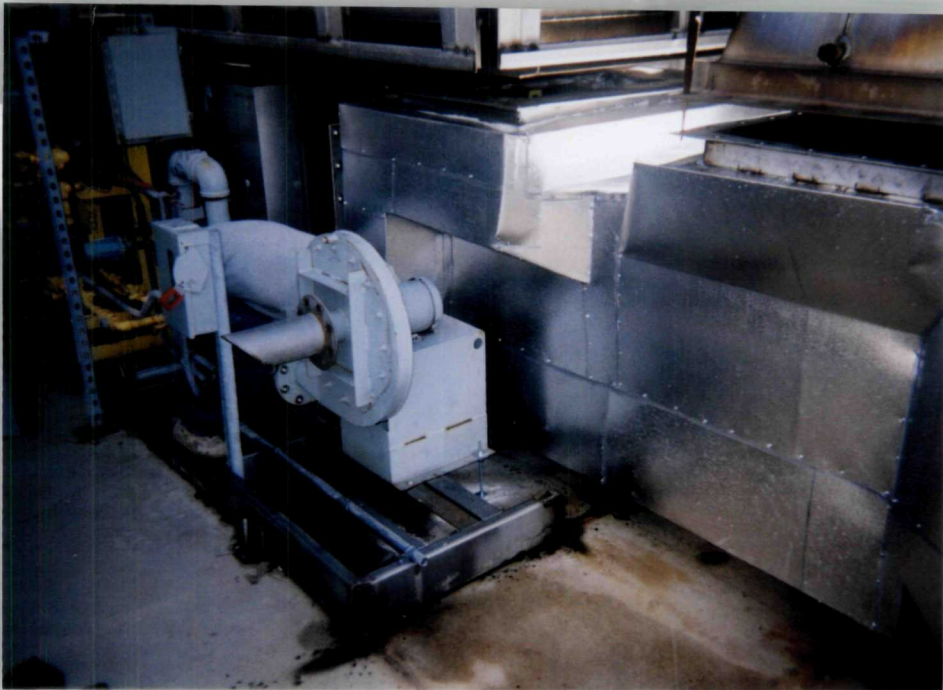
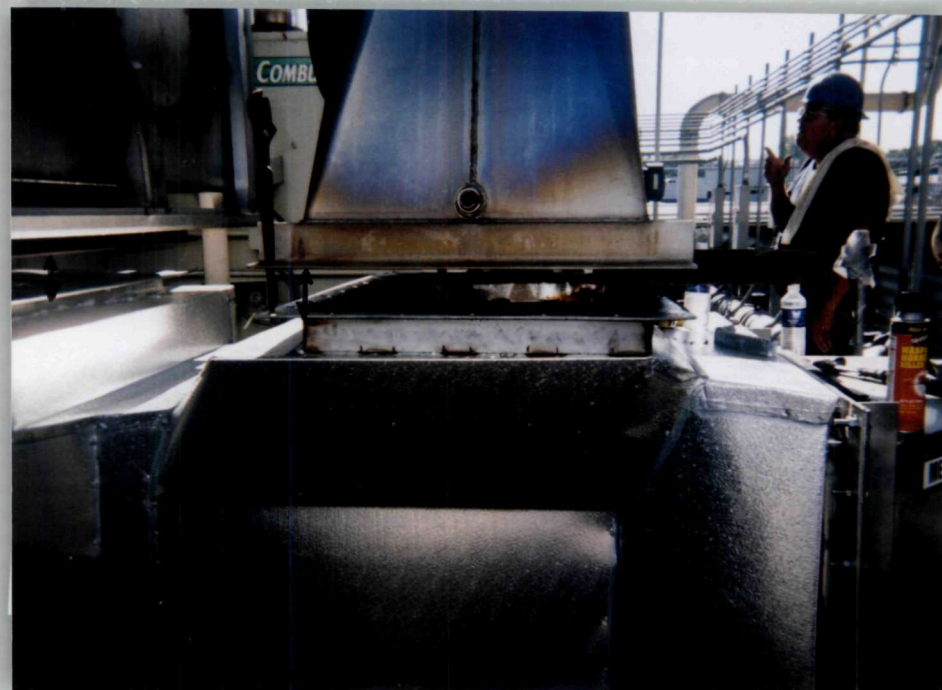
Description: Photo facing east showing 3" gaps between new heat exchanger and existing thermox 1 vapor piping.

On September 13 and 14, Ryan and Central Crane lifted the new heat exchanger, manufactured by Global, to replace the heat exchanger on thermox 1. MWH discovered that the new unit was manufactured incorrectly, and that various connections do not mate with the existing components of thermox 1. Ryan removed the existing steel frame of the old heat exchanger so the new heat exchanger's support legs can rest on the concrete slab. Global is currently manufacturing spacers to fill the 3-inch-wide gaps on the vapor flumes. The new spacers were installed on September 17 and the remaining connections were completed. Restart of thermox 1 is expected next week.

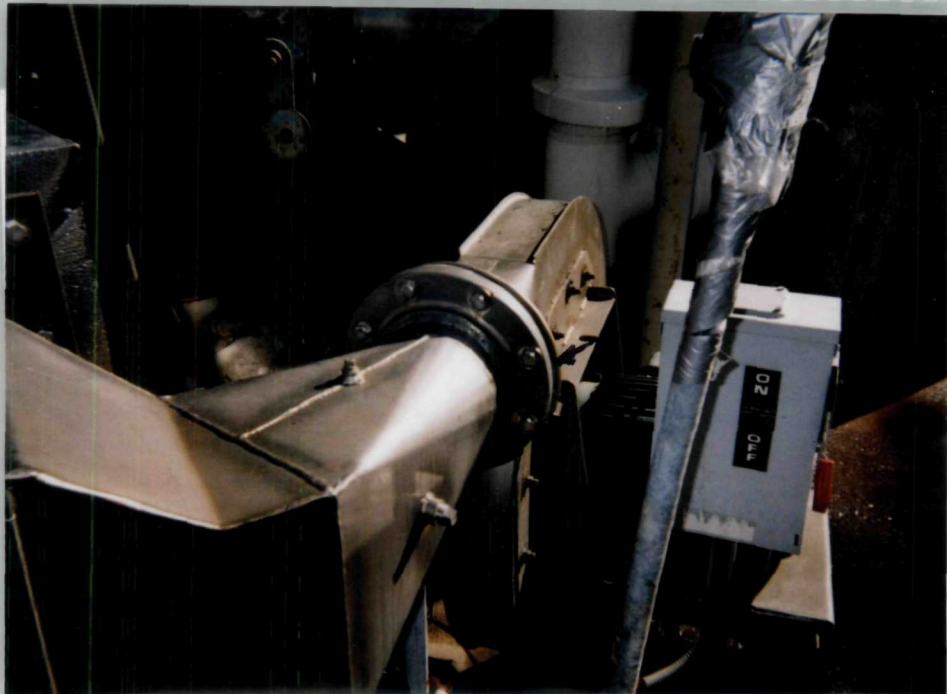
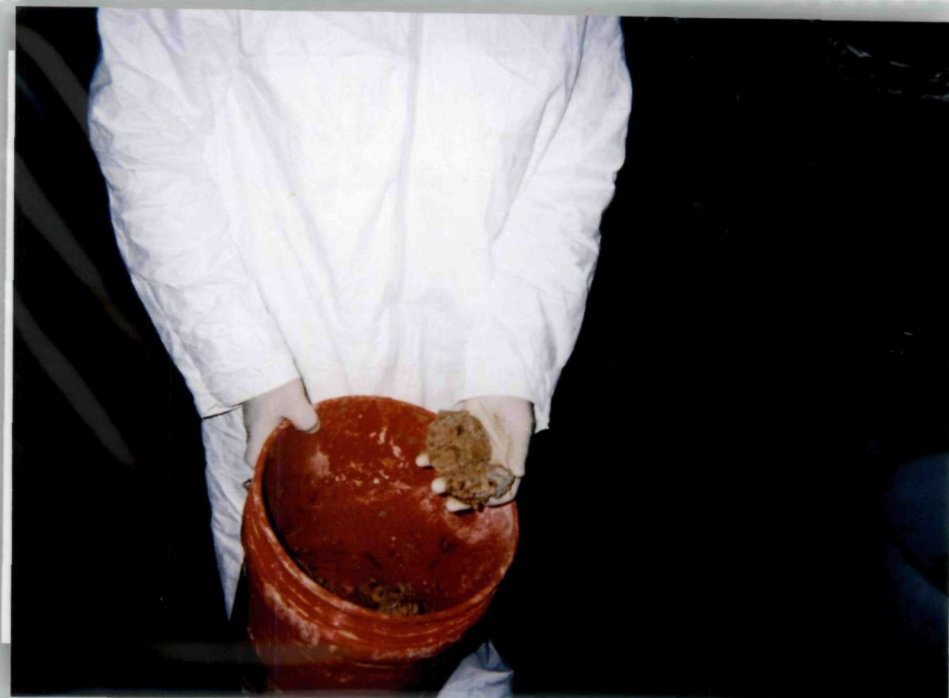
Description: Photo facing south showing corroded packing from Global thermox 2.

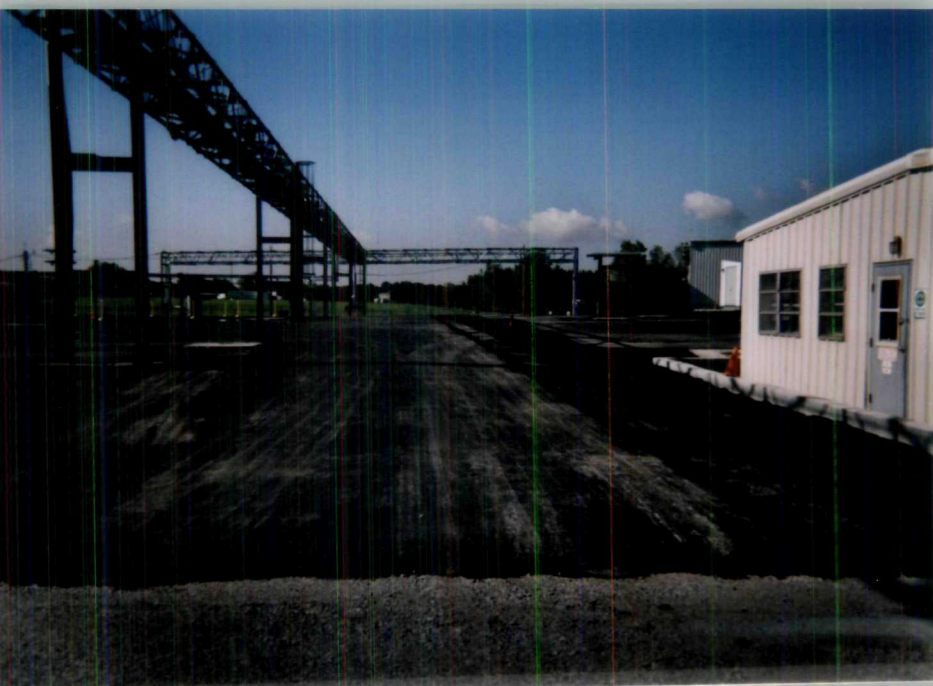
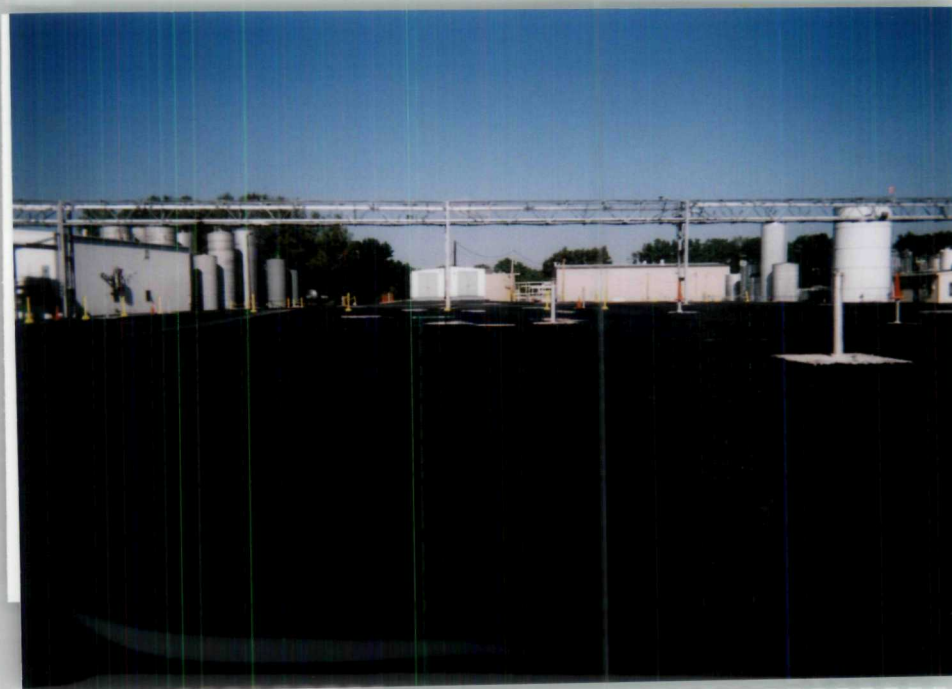
Description: Photo facing west showing completed
SBPA asphalt concrete cover. Note small
"birdbaths" of ponded water on the surface.

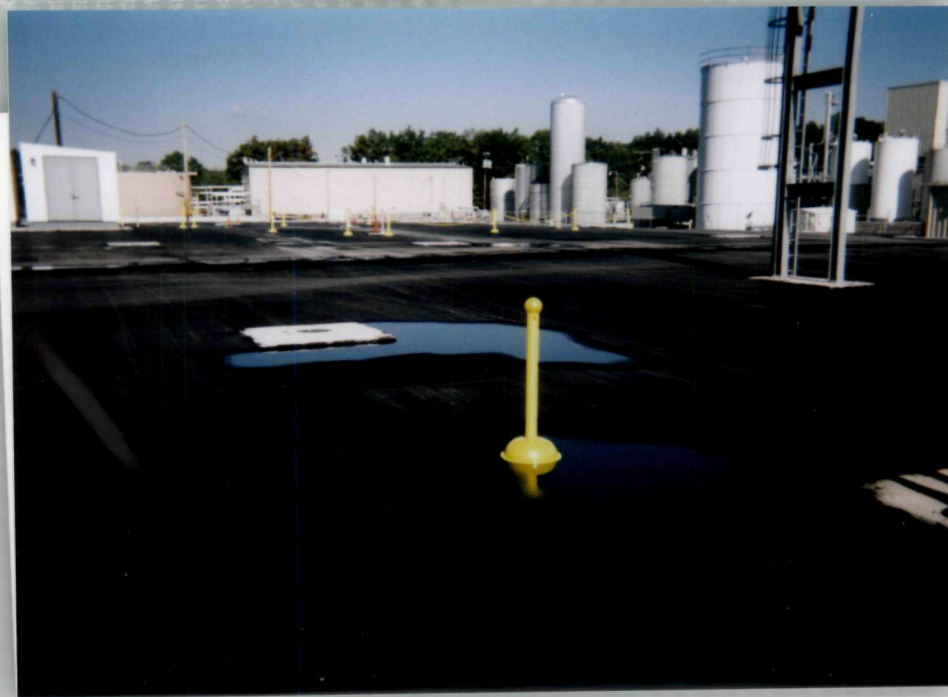
Description: Photo facing west showing small "birdbaths" of ponded water near AS4.

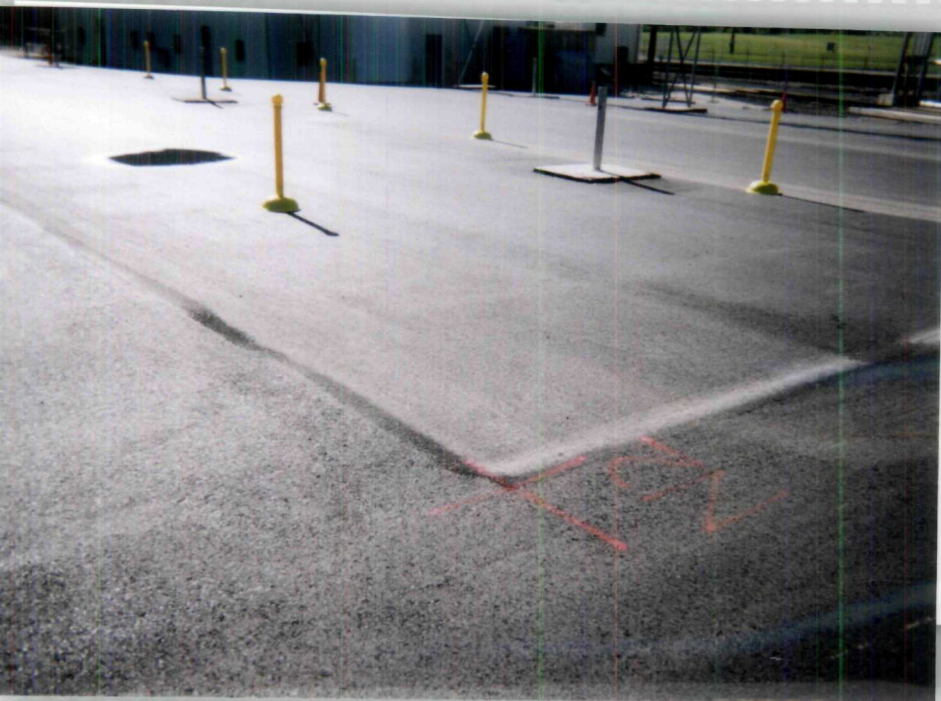
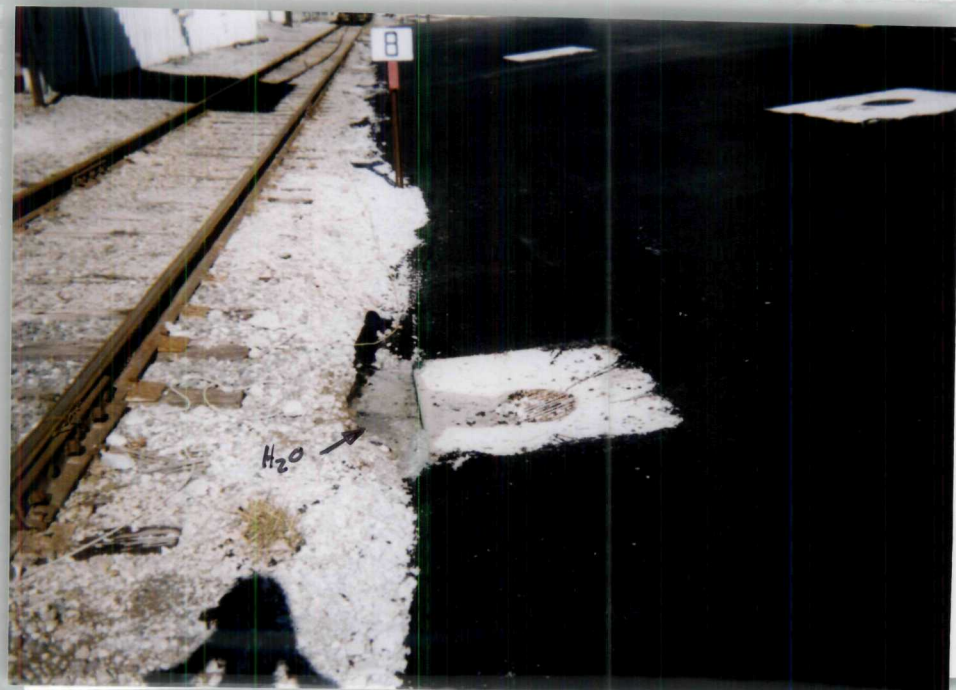
Description: Photo facing west showing central storm drain on south side of SBPA. Note ponded water off of the cover (on L).

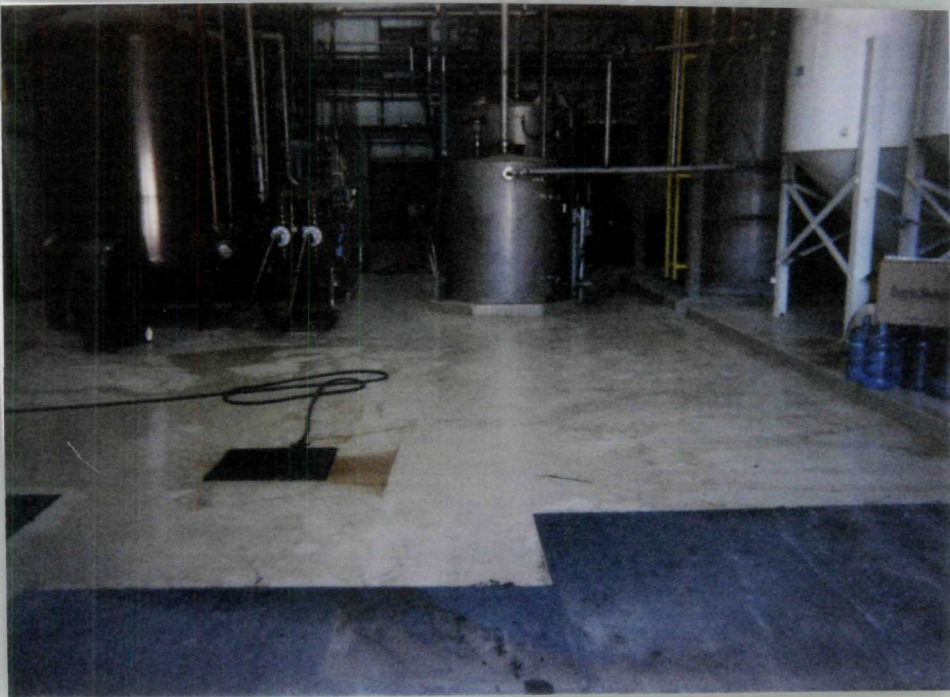
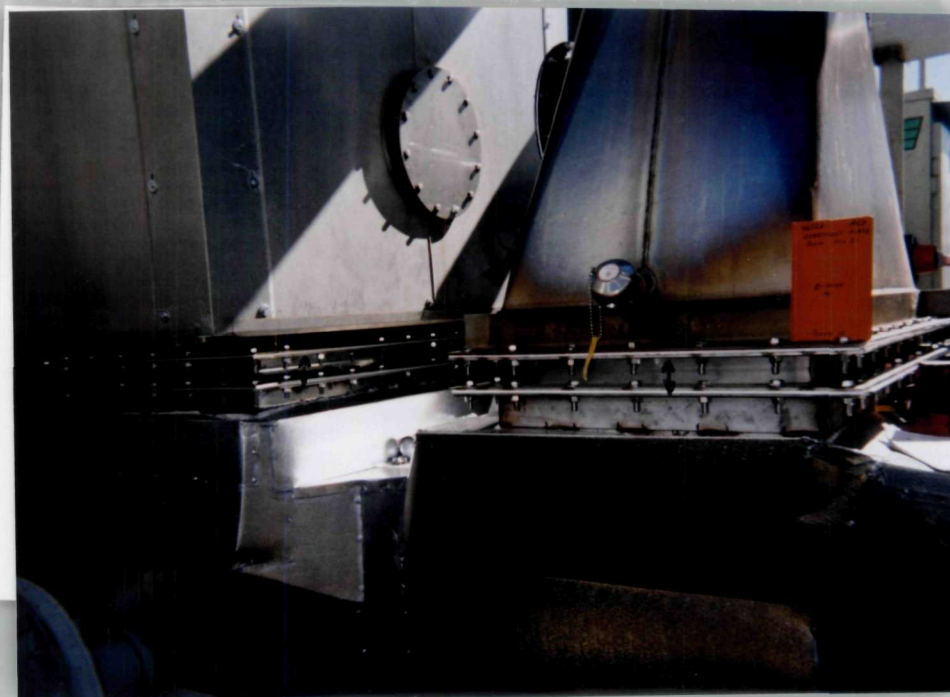
Description: Photo facing east at thermox 1 heat exchanger showing sleeves to fill 3" gap in connections between heat exchanger and vapor piping.

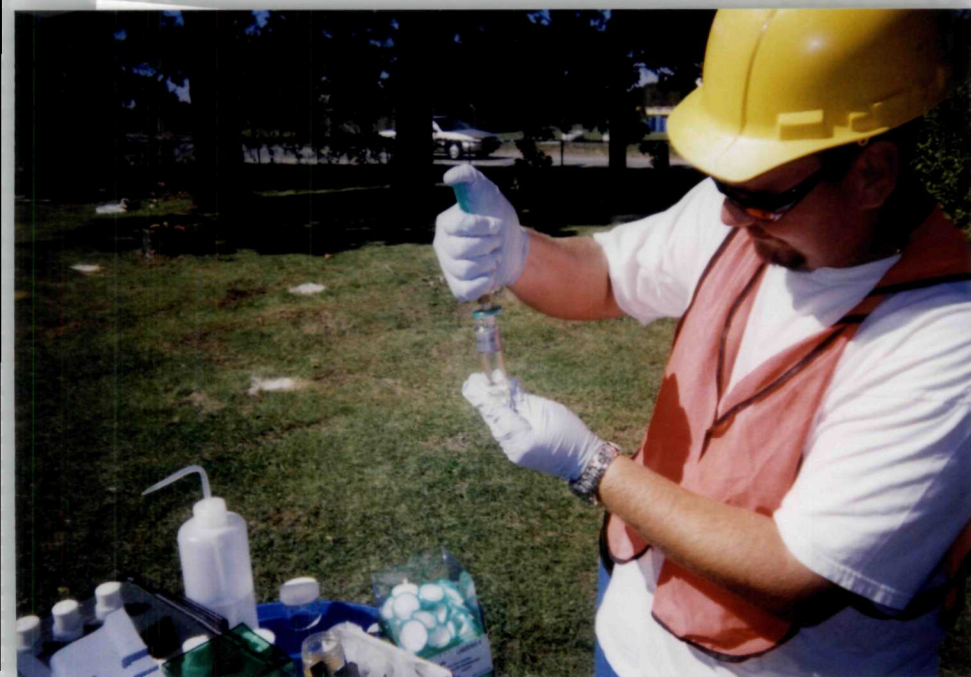
Description: Photo facing east showing ISOTEC collecting groundwater sample from intermediate sampling point to test for peroxide in groundwater.

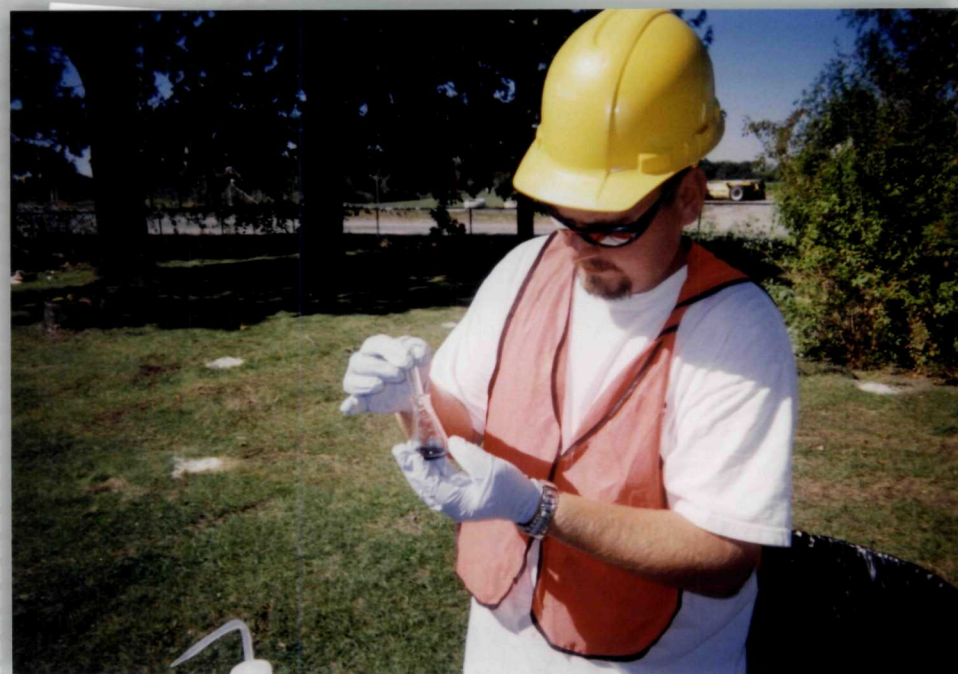
Description: Photo facing southwest showing ISOTEC field filtering groundwater sample. Then added ammonium molybdate and sulfite 1 reagent. Color changed to dark blue.

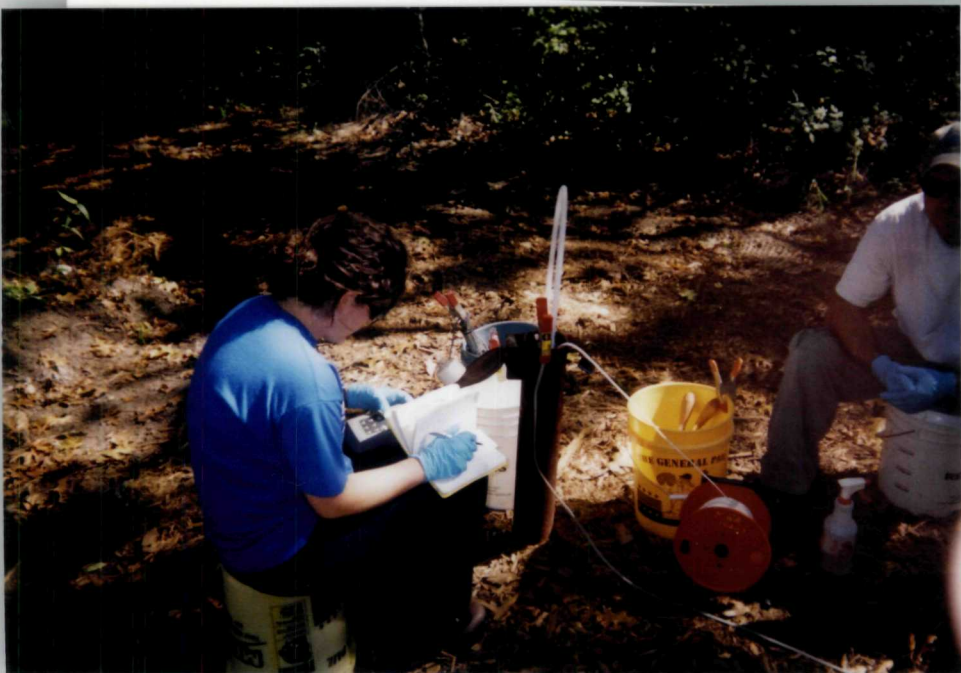
Site: American Chemical Service, Inc.
 Proj. #: 46526
 Roll: 67 Photo #10
 Date: 09-21-04 Time: 1325
 Photographer: Larry Campbell
 Description: Photo facing west showing MWH personnel
 removing peristaltic pump from MW32 near
 railroad tracks at north end of site.

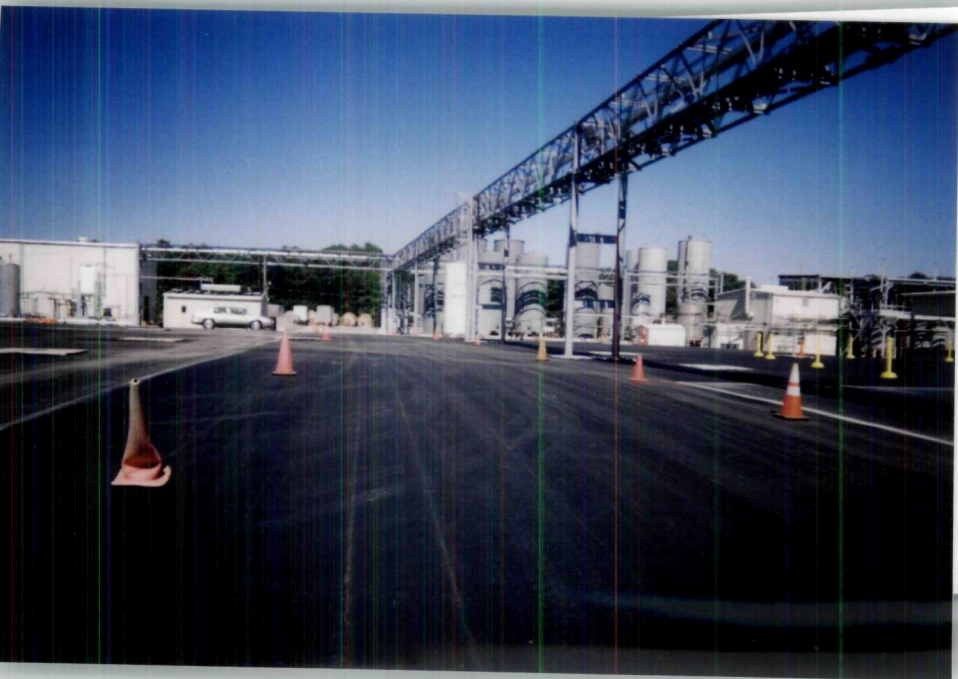
Description: Photo facing east showing new ONCA
SBPA fence stanchions (yellow).

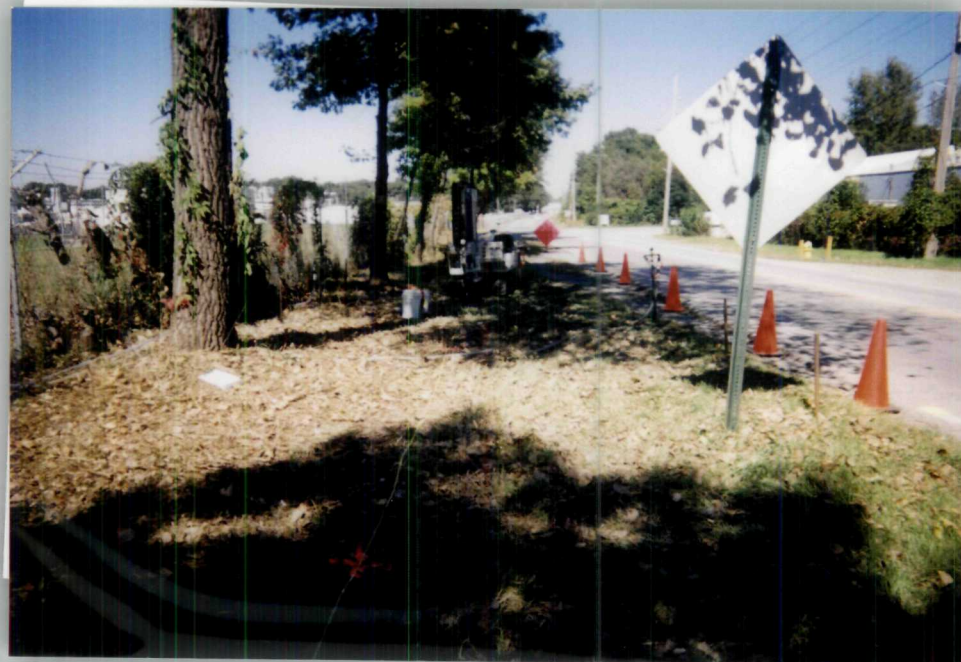
Site: American Chemical Service, Inc.
 Proj. #: 46526
 Roll: 67 Photo #13
 Date: 09-21-04 Time: 1412
 Photographer: Larry Campbell
 Description: Photo facing north showing orange cones
 used to identify "roadway" across SBPA
 cover.

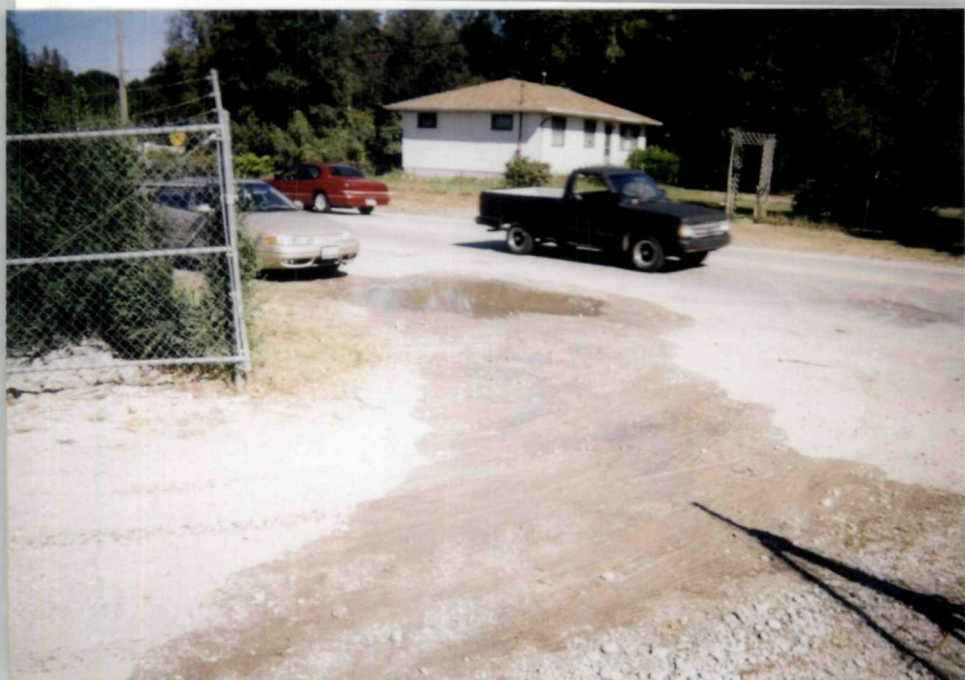
Site: American Chemical Service, Inc.
 Proj. #: 46526
 Roll: 67 Photo #14
 Date: 09-21-04 Time: 1420
 Photographer: Larry Campbell
 Description: Photo facing north showing PSA rig and
 two injection points on west side of Colfax
 Ave.

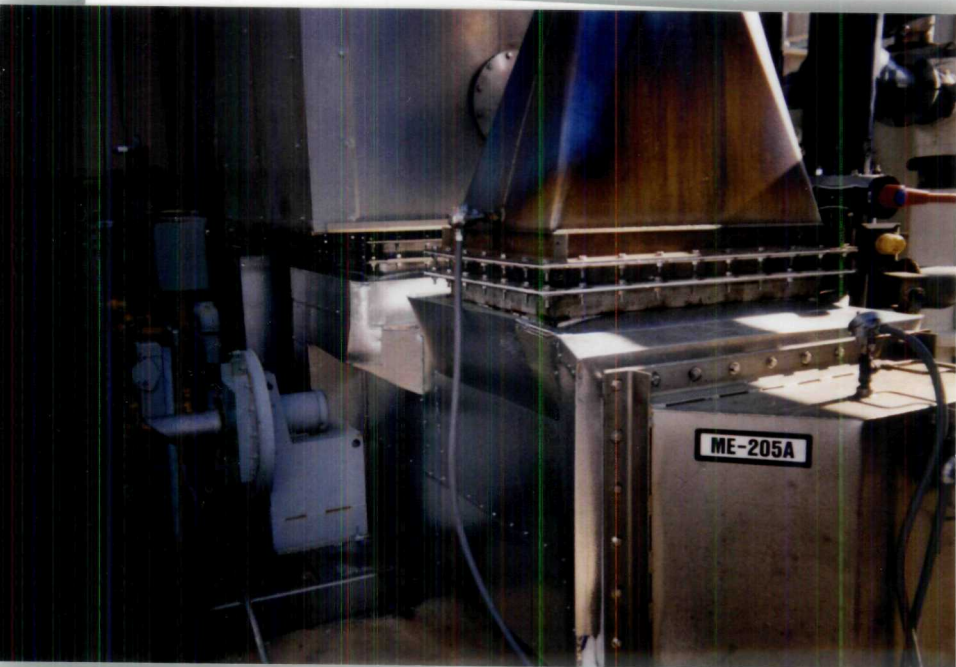
Description: Photo facing north showing fully installed knockout tank at GWTP near thermox 1.
